# Home Inspection Report

5407 Sharpe Dr, Raleigh, NC 27612

Friday September 17, 2021

20210917

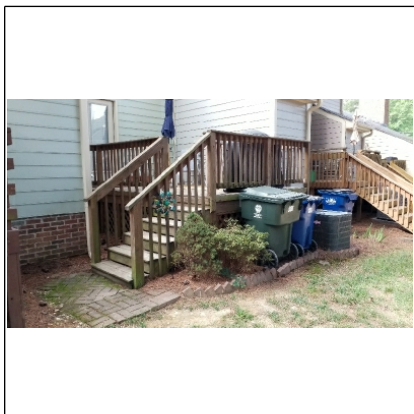
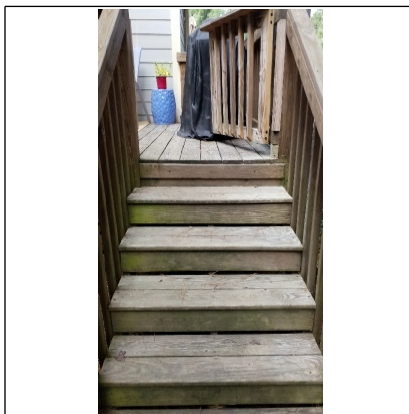
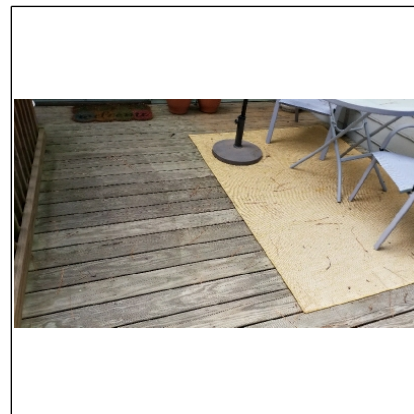
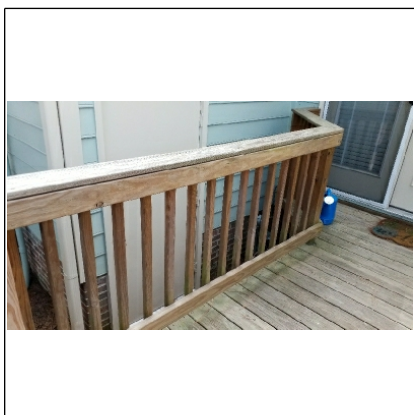
**Comments** The deck has deteriorated stain. Recommend a qualified professional paint/stain the deck or wood deterioration may occur.

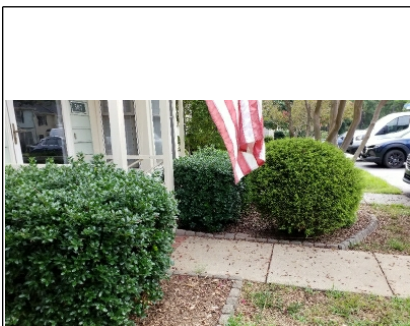
Front grade

**Comments** The grade around the house is relatively flat on all sides. Flat or negative grade around the foundation does not allow rainwater to drain away from the house, which may cause damage to the foundation and/or moisture intrusion in the crawlspace. Recommend repairs by a qualified professional or moisture issues may occur.

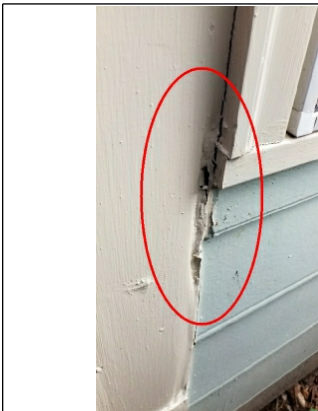
**Comments** There is deteriorated trim and caulk to the left and below the front kitchen windows. Recommend a qualified professional repair the trim or further deterioration and moisture intrusion may occur.

Deteriorated trim/caulk left of front center kitchen window

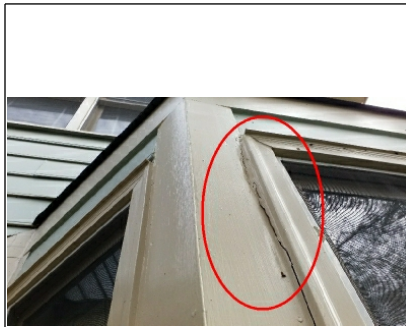
Deteriorated trim/caulk left of front center kitchen window

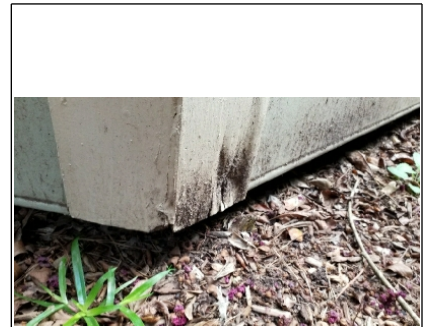
Deteriorated trim under front kitchen window

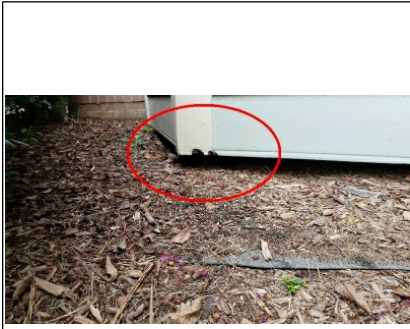
Deteriorated trim on front kitchen window

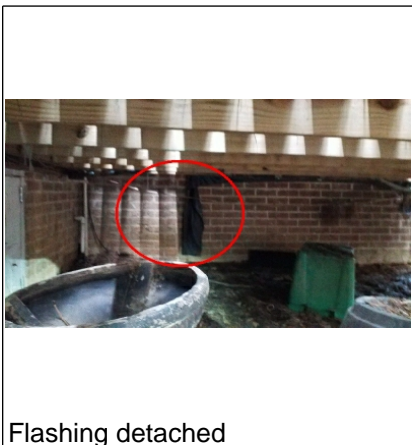
**Comments** The flashing under the left front of the deck is detached. Recommend a qualified professional secure the flashing or further detachment and moisture intrusion may occur.

Flashing detached

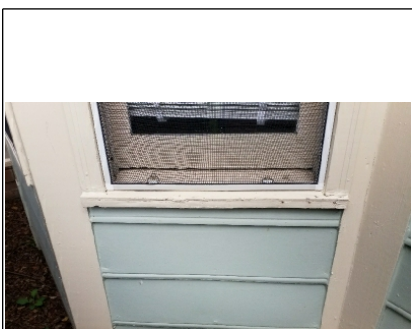
**Comments** The right front kitchen window sill is deteriorated. Recommend a qualified professional repair the sill or further deterioration and moisture intrusion may occur.

Deteriorated window sill; right front kitchen window

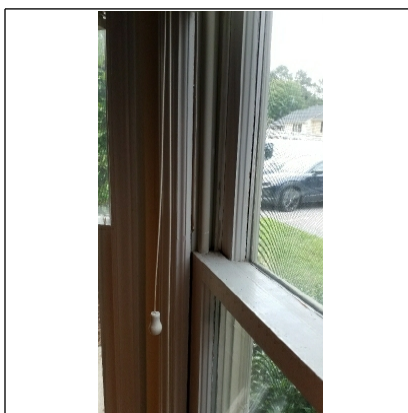
The center kitchen window and right front kitchen window are inoperable and the center kitchen window is not properly secured. Recommend repairs by a qualified professional to ensure proper functionality.

Center kitchen window loose and inoperable

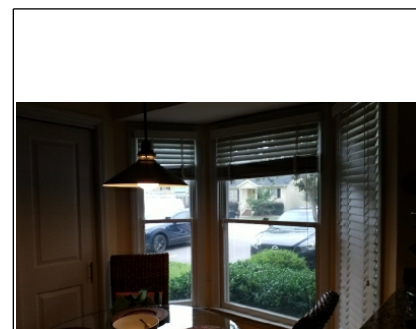
Right front kitchen window inoperable

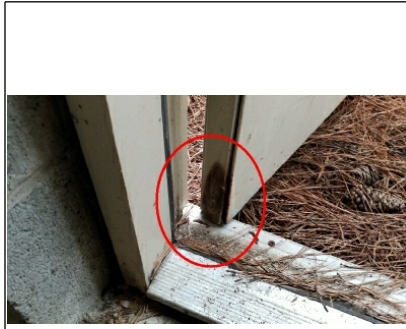
Comments The storage room door rubs slightly at the top corner when closed and has minor moisture damage near the base of the door. Recommend a qualified professional repair the door to ensure proper functionality and protect against moisture intrusion.

Minor moisture damage to door

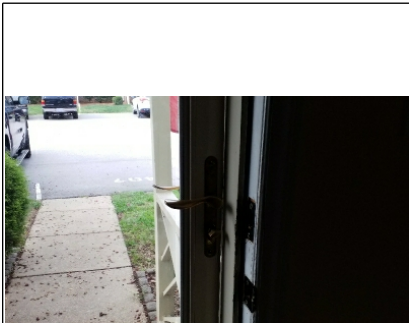
**Comments** The front storm door does not latch properly. Recommend a qualified person adjust the door to ensure proper functionality.

Front storm door does not latch properly

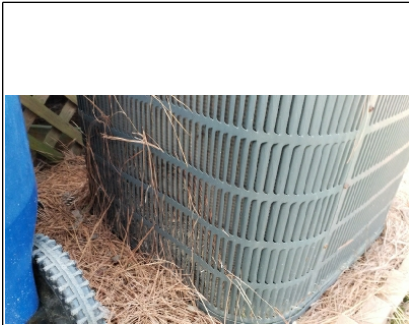
The condenser fins on the A/C unit are full of pine needles and the temperature differential between the supply air and return air was 12 degrees, which is below the 14-22 degree split typically found in a properly functioning unit. Recommend a licensed HVAC contractor further evaluate the A/C unit and make repairs to ensure maximum performance.

Pine needles in condenser fins

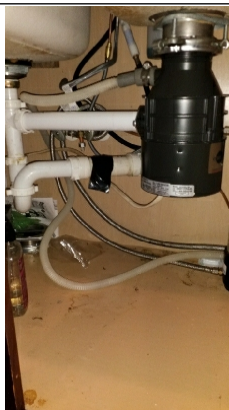
Comments The hot water pressure at the kitchen sink is low. Recommend a licensed plumber make repairs to ensure functional flow.

Low hot water pressure

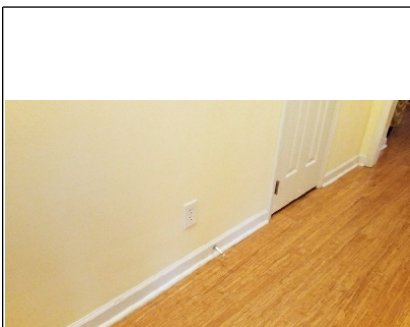
Comments The receptacle on the left wall near the half bath is loose. This is a safety concern. Recommend a licensed electrician repair the loose receptacle or accident/injury may occur.

Loose receptacle in hallway

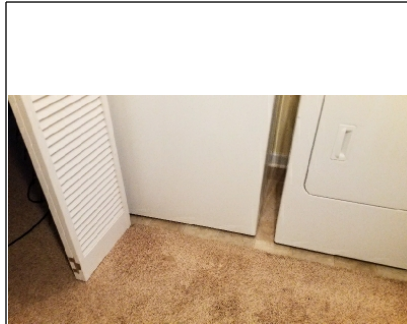
There is no pan installed under the washing machine. Recommend a qualified professional add a pan or water damage may occur if the washer leaks.

No pan under washing machine

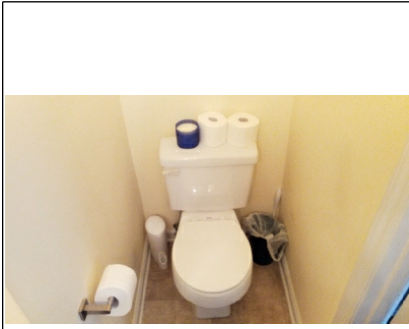
**Comments** The toilet bowl in bathroom (2) is loose. A loose toilet may leak causing damage to the floor and ceiling below. Recommend a qualified person secure the toilet, so leaks are less likely to occur.

Loose toilet

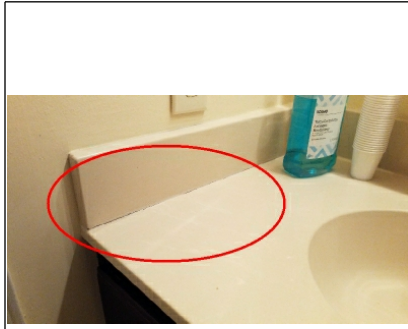
There is deteriorated/missing caulking around the shower faucet ring in bathroom (2) and around the tub spout and faucet ring in the master bathroom. There is also deteriorated caulking on the left side of the vanity in bathroom (2). Recommend a qualified person re-caulk these areas or moisture intrusion may occur.

Deteriorated caulking

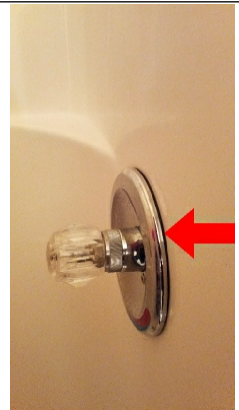
Missing caulking

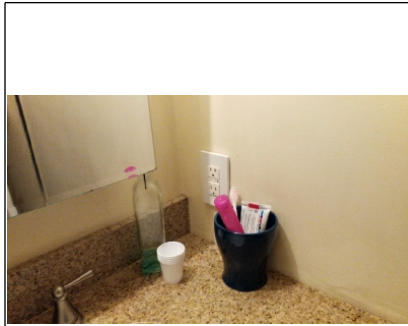
The receptacle in the master bathroom is loose. This is a safety concern. Recommend a licensed electrician repair the loose receptacle or accident/injury may occur.

Loose receptacle

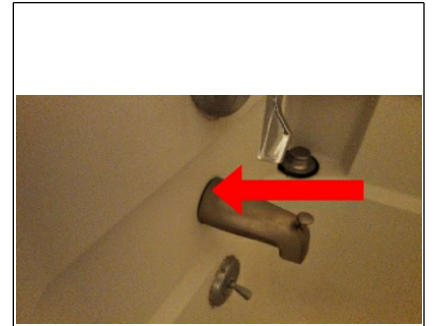
Deteriorated/missing caulking

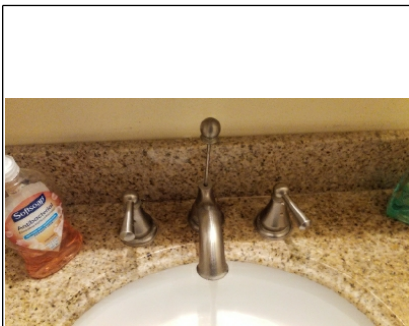
The cold water handle at the master bathroom sink is difficult to turn on and the drain stop is inoperable. Recommend a licensed plumber repair the handle and drain stop to ensure proper functionality.

Cold water handle difficult to turn on

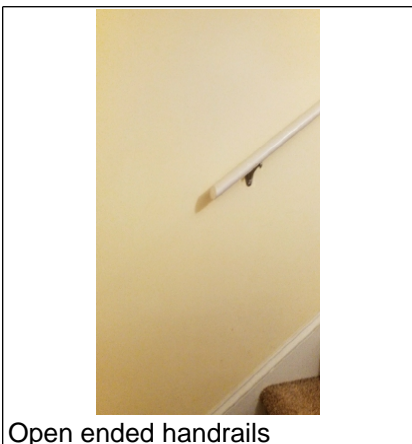
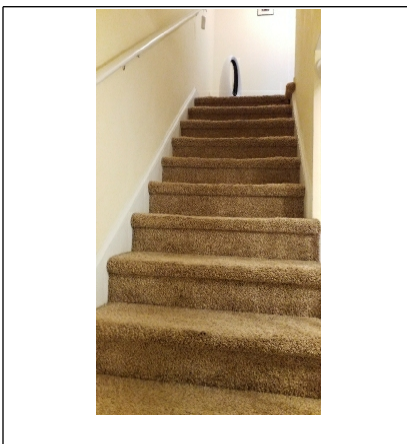
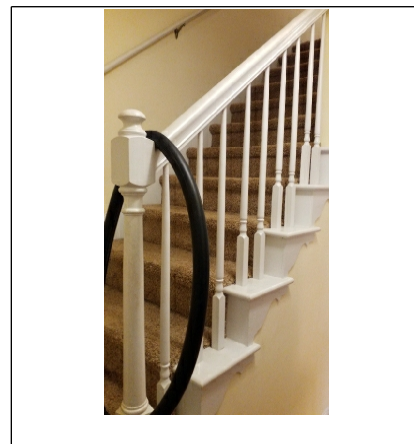
**Comments** The handrail does not return to the wall. When the rails are open on the ends, clothing and personal items can get caught on the railings. Recommend a qualified professional repair the handrail or accident/injury may occur.

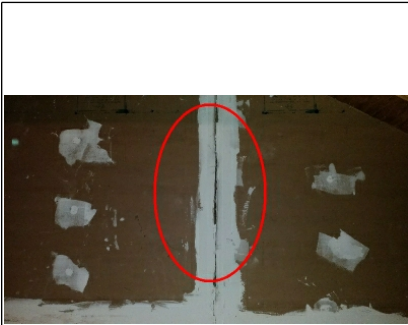
**Comments** The left attic wall is missing proper fire separation at the sheetrock seam near the center of the attic.

Missing fire separation

**Comments cont.** Recommend a qualified professional properly seal the seam or fire may spread more rapidly from one unit to another in the event of a fire.

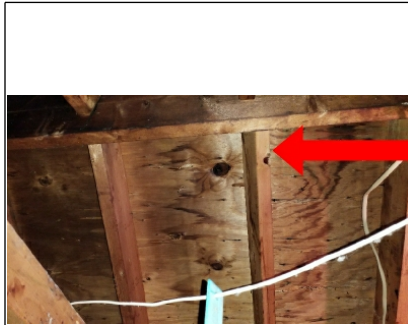
There is a twisted rafter near the front center of the attic. Recommend further evaluation from a licensed contractor to determine if any repairs are needed.

Twisted rafter

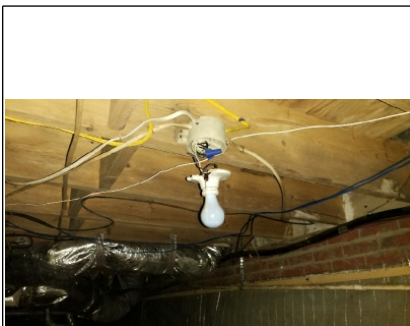
**Comments** The crawlspace light is damaged and inoperable. Recommend repairs by a licensed electrician to ensure adequate lighting.

Light damaged/inoperable

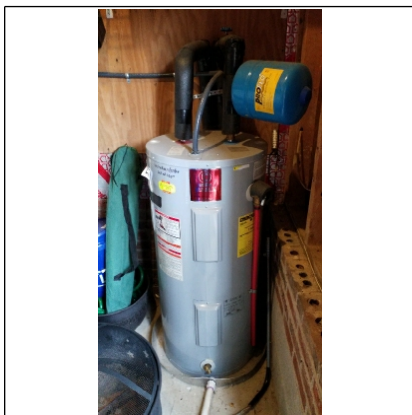
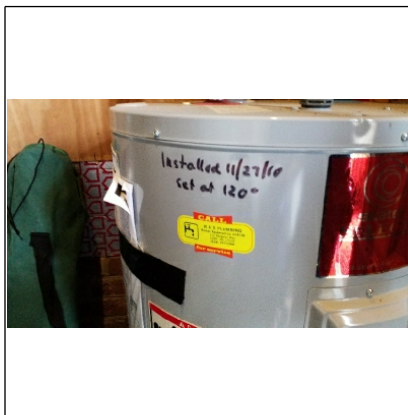
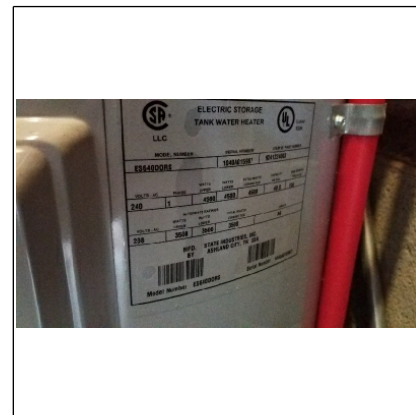
Comments Based on the age of the water heater, it is likely nearing the end of its useful life. Recommend budgeting for replacement.

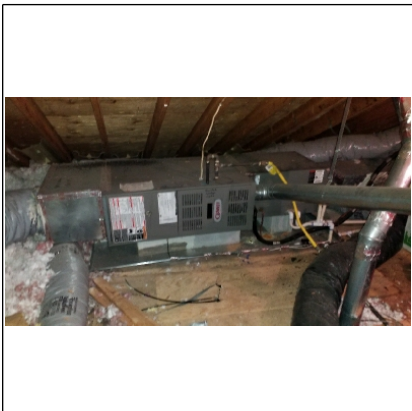
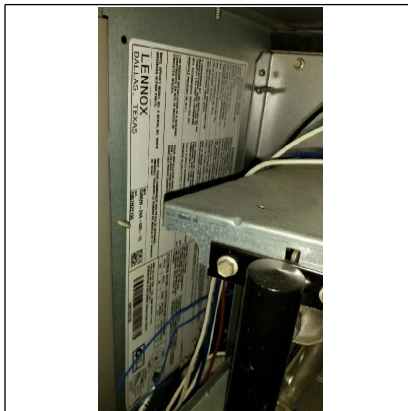
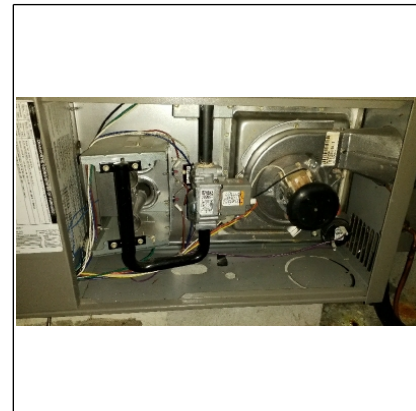
- Unit #1** Brand name: Lennox  
 Approx. age: 14 years old  
 Model #: G40UH-24A-045-15 Serial #: 5907H22196 **X Marginal**
- Unit #2**  None
- Energy source**  Gas
- Warm air system**  Central system
- Heat exchanger**  **Satisfactory**
- Carbon monoxide**  N/A
- Combustion air venting present**  Yes
- Controls** Disconnect:  Yes  No  Normal operating and safety controls observed Gas shut off valve:  
 Yes  No
- Distribution**  Insulated flex duct  Cold air returns
- Flue piping**  **Satisfactory**
- Filter**  Standard  **Satisfactory**
- When turned on by thermostat**  Fired Proper operation:  Yes  No  Not tested
- Heat pump**  N/A
- Sub-slab ducts**  N/A
- System not operated due to**  N/A
- Comments** Due to the age of the furnace, it is likely nearing the end of its useful life. Recommend budgeting for replacement.
