# Home Inspection Report

5407 Sharpe Dr, Raleigh, NC 27612

Friday September 17, 2021

20210917

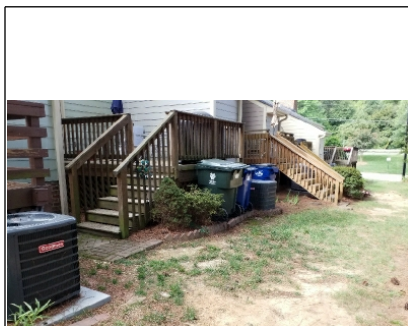
Rear grade

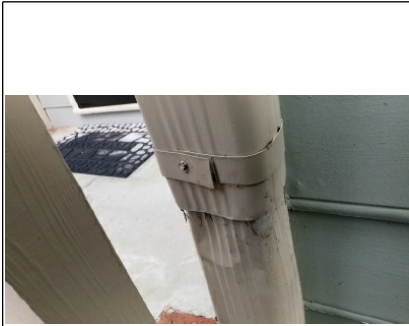
- 2.3 The gutters on the house are full of debris, the left front downspout is not properly connected and not aligned with the downspout extension and the rear downspout is clogged and terminates too close to the ground. Recommend a qualified person clean the gutters and repair the downspouts to ensure proper rainwater runoff.

Left front downspout not properly connected

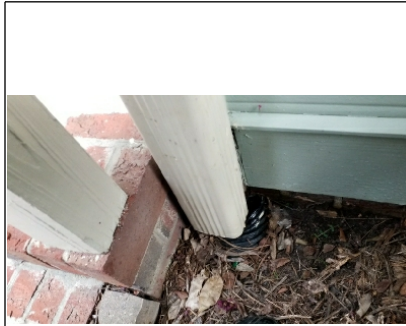
And not aligned with extension pipe

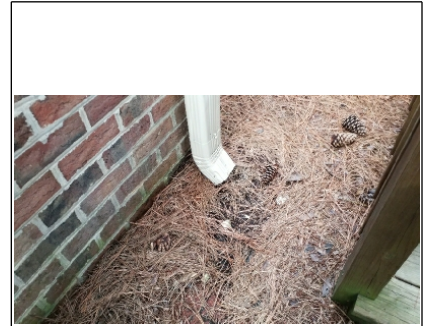
Rear downspout clogged and too close to ground

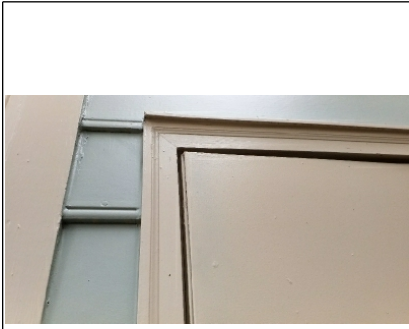
- 2.8 The storage room door rubs slightly at the top corner when closed and has minor moisture damage near the base of the door. Recommend a qualified professional repair the door to ensure proper functionality and protect against moisture intrusion.

Door rubs slightly at top corner

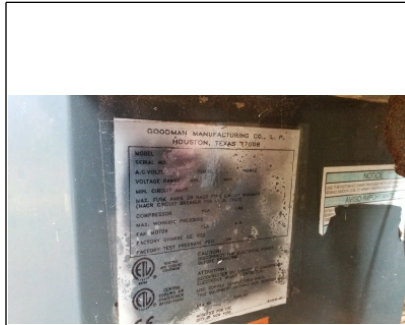
Data tag not legible

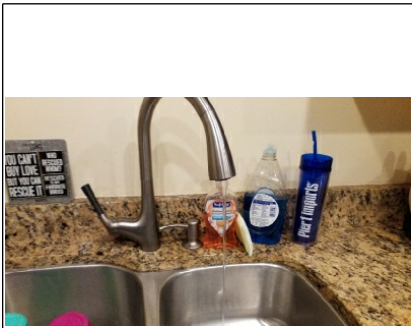
2.11 The hot water pressure at the kitchen sink is low. Recommend a licensed plumber make repairs to ensure functional flow.

Low hot water pressure

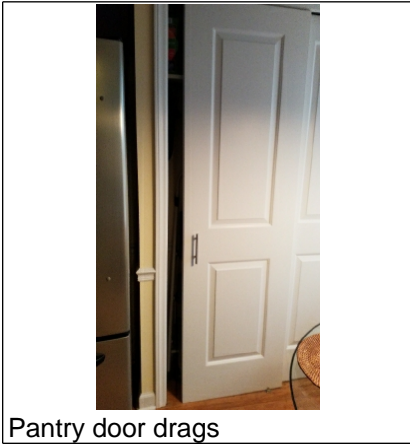
2.12 The left pantry door drags and is difficult to open. Recommend a qualified person adjust the door to ensure proper functionality.

Pantry door drags

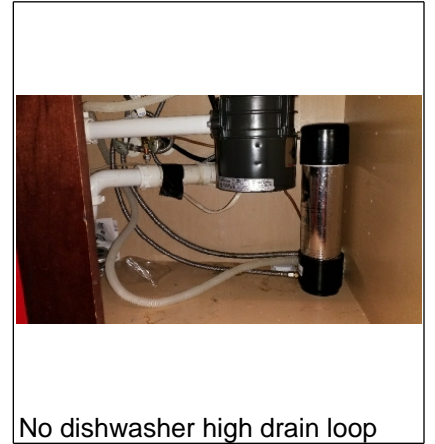
The dishwasher drain does not contain a high drain loop. A high drain loop is necessary to prevent the backflow of contaminated water into the dishwasher. It is possible that there is a high drain loop installed on the dishwasher itself but I am unable to determine that during this limited visual inspection. Recommend re-installing the drain with a high loop or confirming with the manufacturer that the dishwasher has a high drain loop installed. This will eliminate the risk of cross contamination.

No dishwasher high drain loop

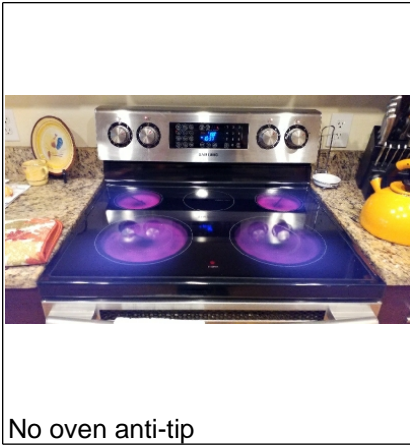
The oven is not equipped with an anti-tip device. Recommend a qualified professional install an anti-tip device or accident/injury may occur if excessive force is applied to the oven door.

No oven anti-tip

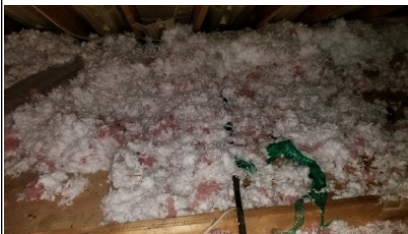
Insulation depth

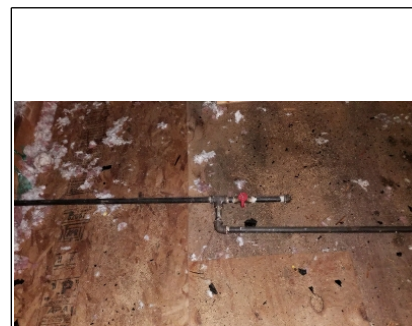
Black iron gas piping

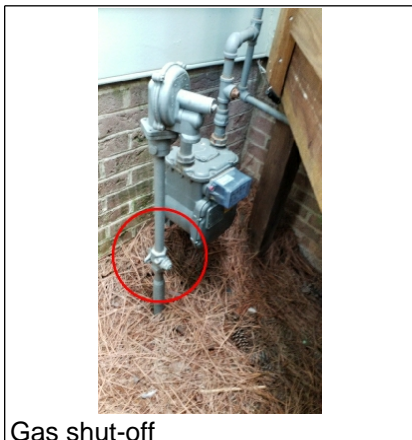
Gas shut-off

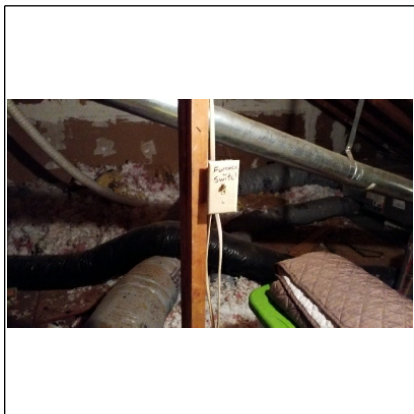
- Unit #1** Brand name: Lennox  
 Approx. age: 14 years old  
 Model #: G40UH-24A-045-15 Serial #: 5907H22196 **X Marginal**
- Unit #2**  None
- Energy source**  Gas
- Warm air system**  Central system
- Heat exchanger**  **Satisfactory**
- Carbon monoxide**  N/A
- Combustion air venting present**  Yes
- Controls** Disconnect:  Yes  No  Normal operating and safety controls observed Gas shut off valve:  
 Yes  No
- Distribution**  Insulated flex duct  Cold air returns
- Flue piping**  **Satisfactory**
- Filter**  Standard  **Satisfactory**
- When turned on by thermostat**  Fired Proper operation:  Yes  No  Not tested
- Heat pump**  N/A
- Sub-slab ducts**  N/A
- System not operated due to**  N/A
- Comments** Due to the age of the furnace, it is likely nearing the end of its useful life. Recommend budgeting for replacement.

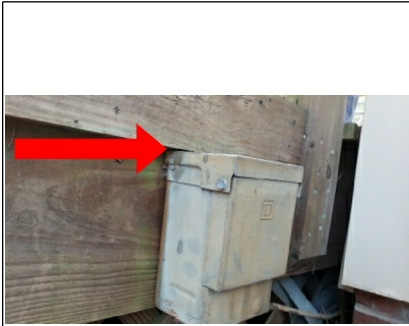
**Condition**  Poor

**Comments** The sub-panel cover could not be removed due to the deck board that is mounted directly above the panel. Recommend a qualified professional lower the sub-panel to allow proper access.

Cover can't be removed due to deck board against cover

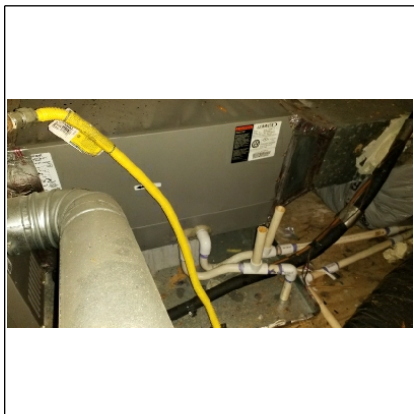
**Condition**       Poor  Recommend HVAC technician examine/clean/service

**Comments**      The temperature differential between the supply air and return air was 12 degrees, below the suggested range of 14-22 degrees. Recommend a licensed HVAC contractor further evaluate and make repairs to ensure maximum performance.
